## Waterstain

### UNDERSTANDING MOISTURE'S EFFECTS AND DEALING WITH STAINS

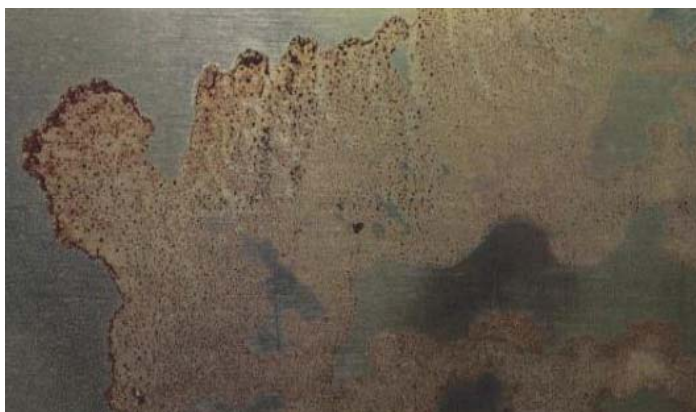
Waterstain, also known as corrosion or white rust, is caused by the entrapment of moisture between adjacent surfaces of metal or other mated surfaces where air circulation is impeded.

A variety of stains can appear as a result of moisture

- Appearance varies from iridescent to white, gray or black in more severe cases.
- The appearance is dependent on the severity of the stain and also the alloy.
- High purity alloys are somewhat more resistant to waterstain while the stain tends to appear more pronounced on alloys with high magnesium content.

Waterstain can only be effectively removed through mechanical abrasion such as buffing or grinding.

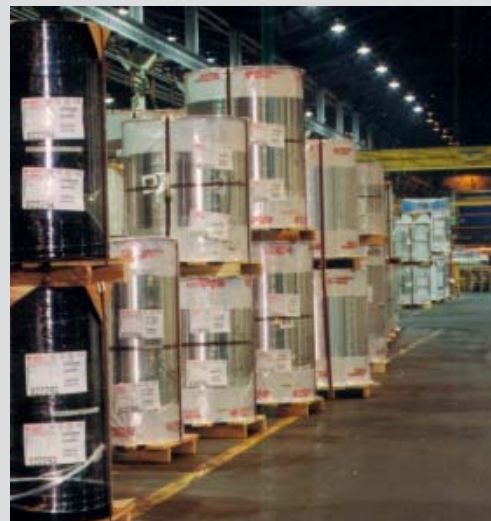
- It is perhaps the most difficult source of moisture to prevent.
- It can be prevented by avoiding conditions where the temperature of the metal drops below the dew point of the surrounding air; or, conversely, conditions where the moisture of the air increases enough to carry the dew point above the metal temperature.
- It is therefore important to ensure that a sudden fall in temperature or increase in humidity will not occur in the metal storage area.
